NASA Technical Memorandum 4608

# Thermo-Oxidative Stability of Graphite/PMR-15 Composites

## Effect of Fiber Surface Modification on Composite Shear Properties

Madhu S. Madhukar, Kenneth J. Bowles,  
and Demetrios S. Papadopoulos

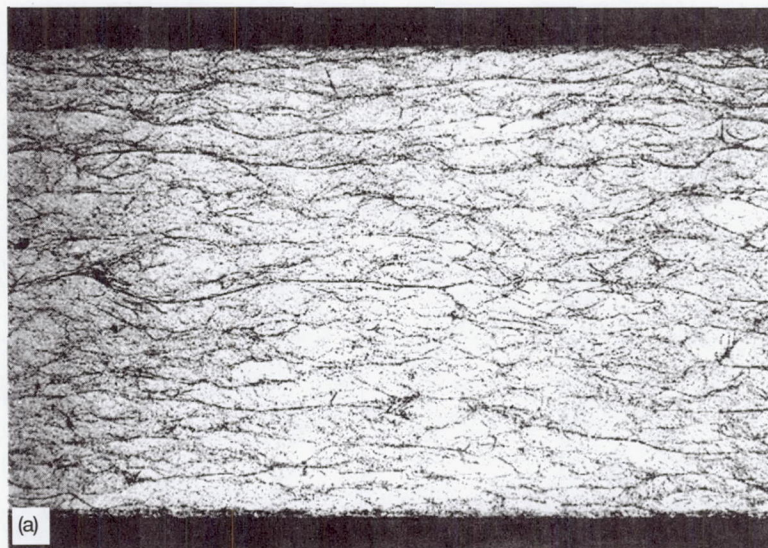
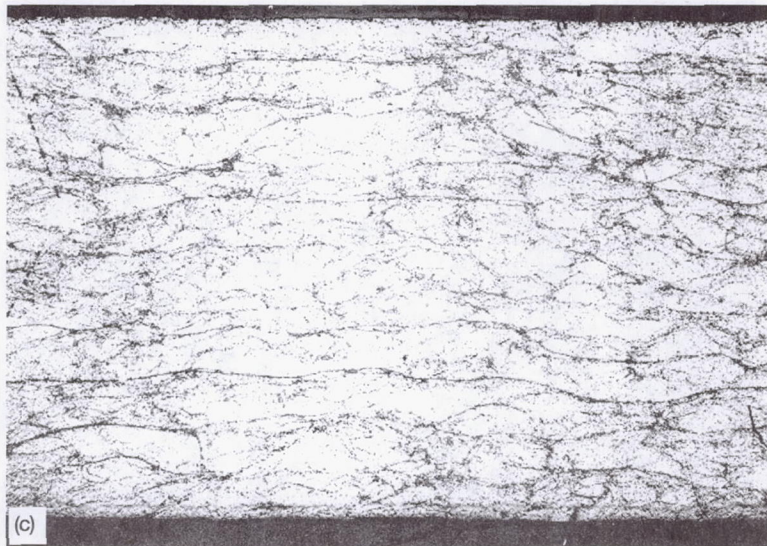
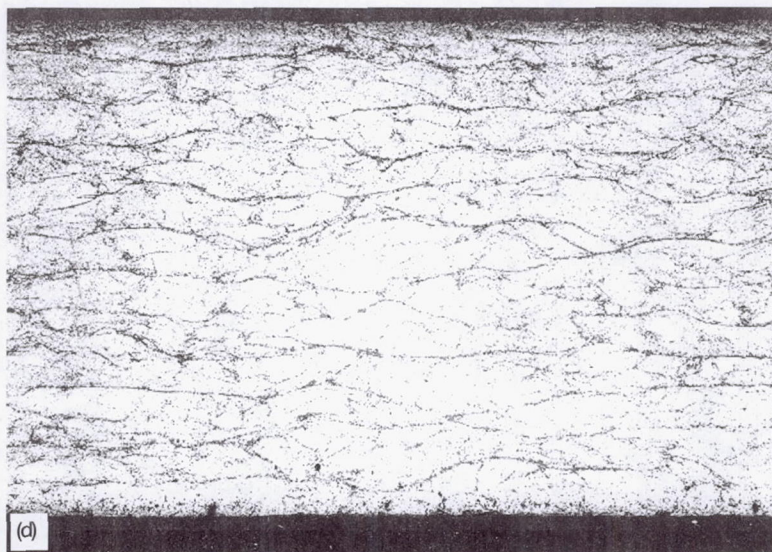
Figure 8.—Damage on cut surface of AS-4/PMR-15 specimens aged for different times at 316 °C. (a) 0 hr, unaged. (b) 240 hr.

Figure 8.—Concluded. (c) 500 hr. (d) 1000 hr.

**Microcracking of composites during the thermal aging.**—From each composite panel aged at different times, small specimens were machined from the edges to detect the extent of microcracking caused by the thermal aging. The micrographs of the specimens showing surface 3 (fig. 5) are presented in figures 7 to 9. In all the cases, the composite degradation occurred near the specimen edges. As the aging time increased, a distinct layer of degraded matrix formed at the uncut surfaces and grew inward between the reinforcement fibers. As the degraded matrix layer grew inward, matrix cracks developed perpendicular to the uncut surfaces. The AU-4/PMR-15 specimens had the greatest number of these matrix cracks (fig. 7). At 1000 hr of aging time, the matrix cracks in AU-4/PMR-15 specimens were about 1 to 2 plies deep and about 0.5 to 0.75 mm apart. In comparison, in the AS-4/PMR-15 specimens, the crack depth of the degraded surface layer and the extent of matrix cracking (average crack spacing) were much less (fig. 8). In the AS-4G/PMR-15 specimens, as the aging time increased, void formation occurred near the uncut edges. With aging time, the voids grew in size as well as in concentration. The matrix cracks emanated from these voids and grew inward. Figure 9 shows a dark surface layer produced by the high concentration and coalescence of voids. It is believed that the epoxy-compatible sizing layer present on the AS-4G fibers does not mix with the PMR-15 matrix during the processing of the composites. This layer could have been easily destroyed during the aging (since the  $T_g$  of commonly used epoxies is only about 135 °C), thus leaving behind a space between the fiber and the PMR-15 matrix. The thermal degradation proceeded
